Property Risk Consulting Guidelines

PRC.12.0.3

MICROBIOLOGICALLY INFLUENCED CORROSION IN SPRINKLER SYSTEMS

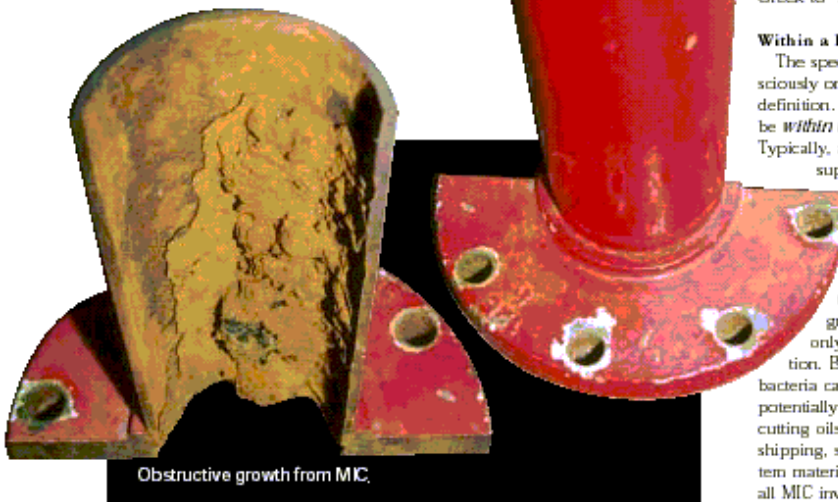
Obstructive growth from MIC.

Second, and more concerning, is the failure of a system to achieve its designed purpose: that of fire control. Several systems with MIC have been found with sprinkler drops completely plugged with the debris generated as a byproduct of the MIC process (called biofilm or biosludge). Sprinkler system feed mains have also been found with up to 60% obstruction from biological growth.⁶ This could present an obvious hydraulic concern as many sprinkler systems today will not provide fire control with just a 15%-20% flow reduction due to design.

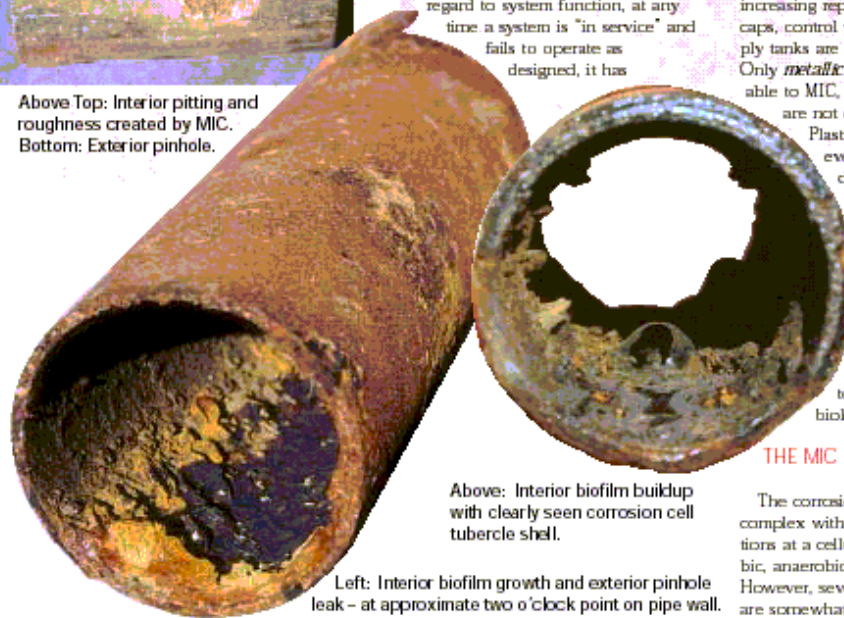
Above: Interior biofilm buildup with clearly seen corrosion cell tubercle shell.

Left: Interior biofilm growth and exterior pinhole leak - at approximate two o'clock point on pipe wall.
